**Flood Control Project Maintenance  
Levee Inspections  
LMA District Cover Sheet  
Spring 2010 Levee Inspection Results**

**Sutter Maintenance Yard Maintenance Area 0016**

**Levee Inspection Report By Mile - Spring 2010**

Waterway						Bank	Unit Miles	Inspection Start/End	Inspector	
Unit No. 01 Feather River						Right	4.09	04/14/2010 04/14/2010	Clay Thomas	
LMR No	Levee Mile		Category	Item	Location *	Rating **	Action/Comment	GPS Latitude/Longitude		Issue No. Photo
	Start	End						Start	End	
1	0.00	4.09	Earthen Levee	Vegetation	LS	A	Control annual grass and weeds on the levee slopes and easements.	39.255770 ° -121.636370 °	39.311078 ° -121.637615 °	1 Y
2	0.00	4.09	Earthen Levee	Vegetation	WS	M	Control annual grass and weeds on the levee slopes and easements.	39.255770 ° -121.636370 °	39.311077 ° -121.637616 °	3 Y
3	0.06	0.10	Earthen Levee	Encroachments	LS	PO	Landscaping	39.256618 ° -121.636442 °	39.257228 ° -121.636462 °	2 Y
4	0.18	0.18	Earthen Levee	Encroachments	LS	PO	Buildings	39.258437 ° -121.636613 °	39.258437 ° -121.636613 °	15 Y
5	0.45	0.49	Earthen Levee	Encroachments	LS	CO	Buildings	39.262213 ° -121.636545 °	39.262825 ° -121.636430 °	7 Y

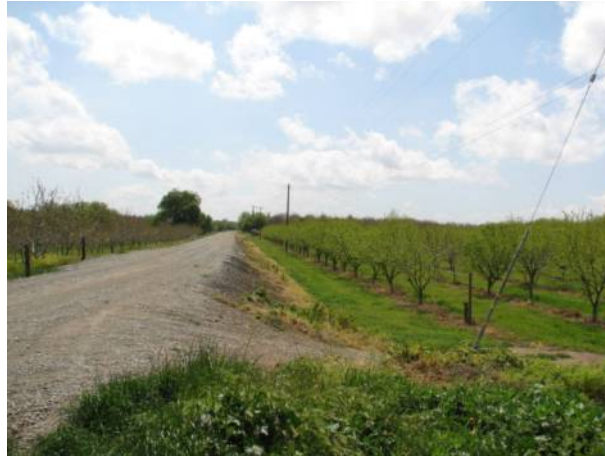
Levee Mile Report Line	1
Start Levee Mile	0.00
End Levee Mile	4.09
Location	Land Side
Category	Earthen Levee
Item	Vegetation

Land side vegetation levee mile 4.09.

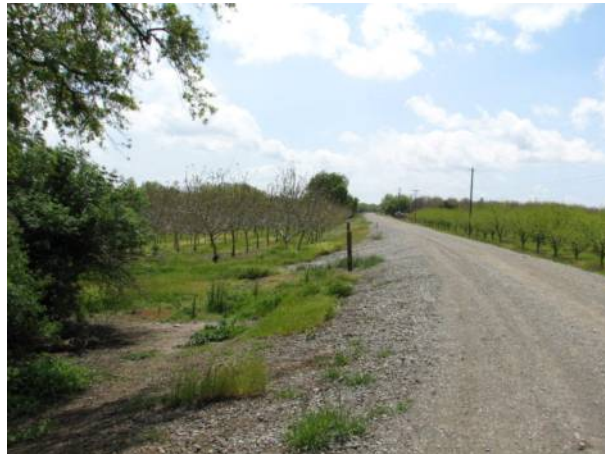
Levee Mile Report Line	2
Start Levee Mile	0.00
End Levee Mile	4.09
Location	Water Side
Category	Earthen Levee
Item	Vegetation

Water side vegetation levee mile 4.09.

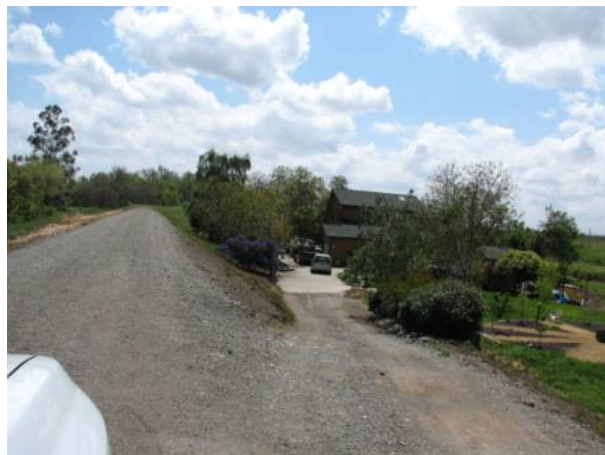
Levee Mile Report Line	3
Start Levee Mile	0.06
End Levee Mile	0.10
Location	Land Side
Category	Earthen Levee
Item	Encroachments

Land side levee mile 0.10.

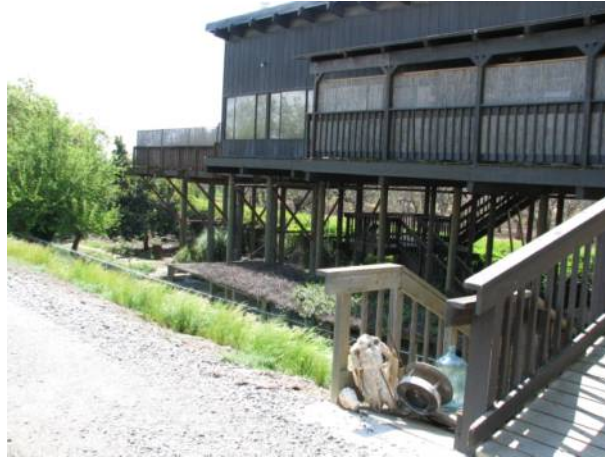
Levee Mile Report Line	4
Start Levee Mile	0.18
End Levee Mile	0.18
Location	Land Side
Category	Earthen Levee
Item	Encroachments
Land side levee mile 0.18.	
cathom_s_20100520_052.jpg

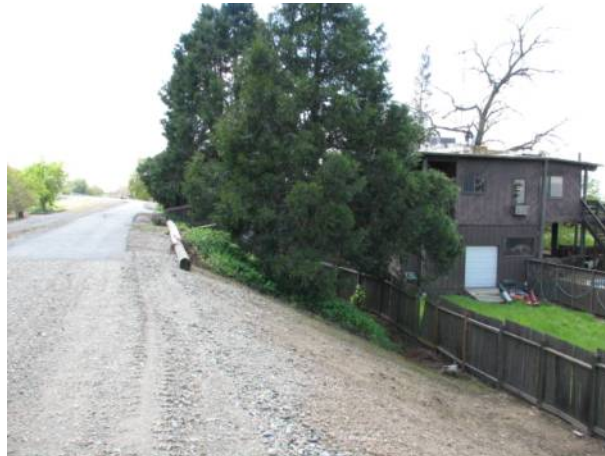
Levee Mile Report Line	5
Start Levee Mile	0.45
End Levee Mile	0.49
Location	Land Side
Category	Earthen Levee
Item	Encroachments
Land side levee mile 0.49.	
cathom_s_20100520_051.jpg

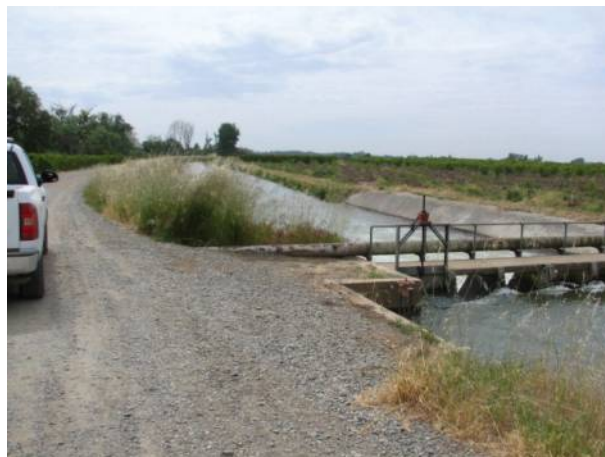
6	2.85	3.08	Earthen Levee	Encroachments	LS	PO	Agricultural Ditch	39.293675 ° -121.636615 °	39.296748 ° -121.638192 °	14 Y

Levee Mile Report Line	6
Start Levee Mile	2.85
End Levee Mile	3.08
Location	Land Side
Category	Earthen Levee
Item	Encroachments
AG ditch land side slope and toe.	
cathom_s_20100316_003.jpg

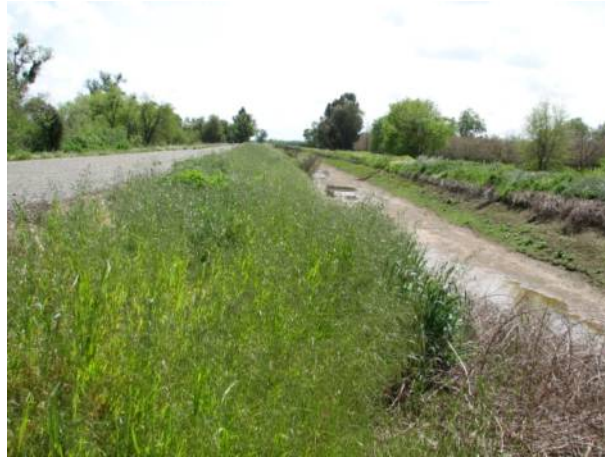
Levee Mile Report Line	6
Start Levee Mile	2.85
End Levee Mile	3.08
Location	Land Side
Category	Earthen Levee
Item	Encroachments

Land side ditch levee mile 3.08.
